POPPLETON HISTORIC STUDY

3-11 N. Schroeder Street

B-2572 3-11 N. Schroeder Street Block 0202, Lots 024-028 Baltimore City Baltimore West Quad

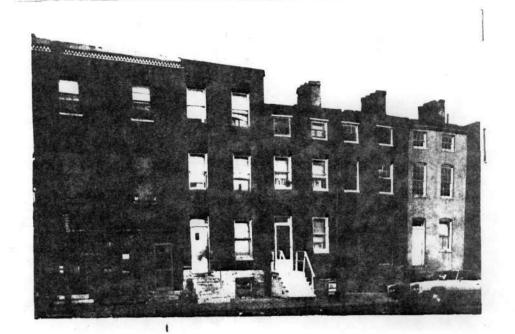
Number 11 has a deep back building on Fairmount and a side entry. Numbers 3, 5 and 7 have gable roofs, 9 and 11 flat roofs. Number 3 retains 6/6 windows. All but number 11 are raised above the street by a flight of steps, a feature which assists in dating them.

These buildings are in a bad state of repair. They could be rehabilitated for housing but are not important enough to require listing; their fate depends on an overall plan for the immediate area. Schroeder Street is very wide and buildings opposite have been demolished. Street trees are needed.

DEMOLISHED

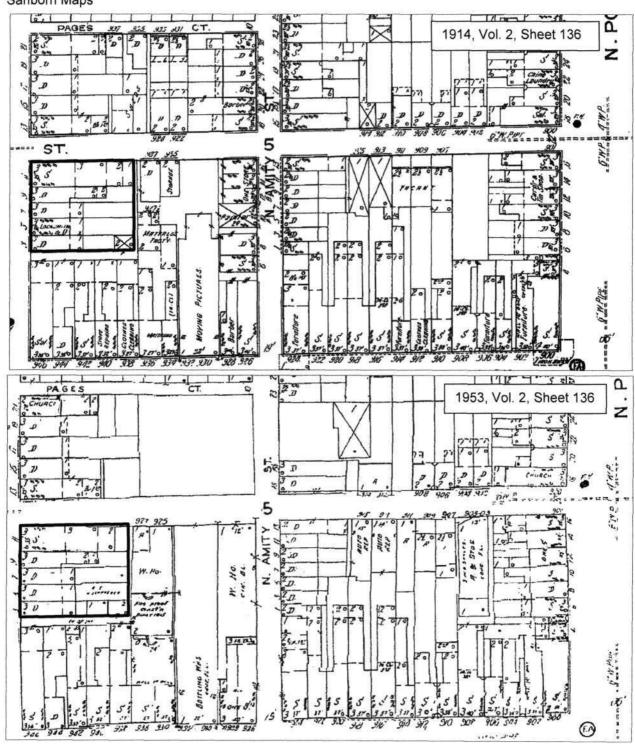
Demolished
